STRUCTURE NO. 1 - WILLIAMS CREEK

6 **PHASE 1 INSPECTION REPORT**
NATIONAL DAM SAFETY PROGRAM.

Structure Number 1 - Williams Creek Dam
(MO 10728), Missouri - Kansas City Basin,
Clay County, Missouri. Phase I Inspection
Report.

PHASE I REPORT

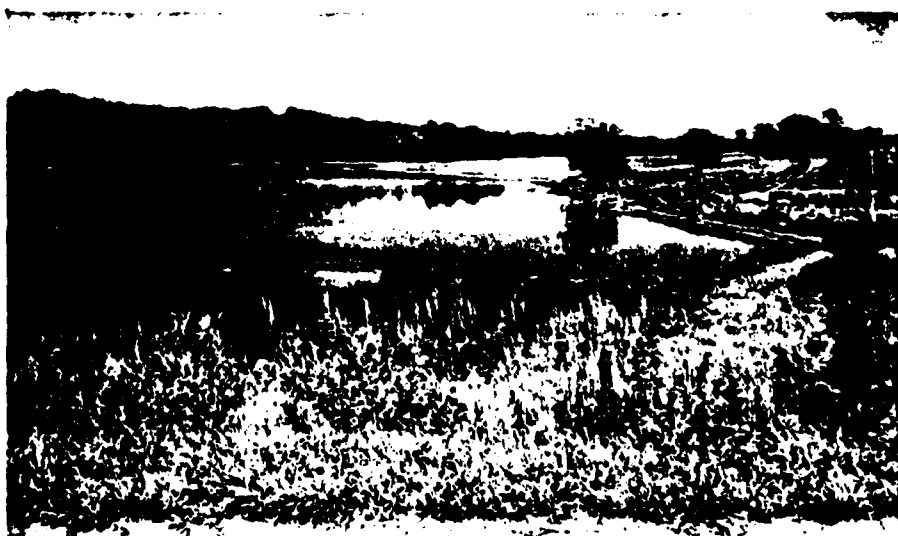
PHOTO NO. 13
LEFT SHORE
OF RESERVOIR
FROM DAM
